maisha borehole report 2011

1. Description of the project funded, activities and the services provided

7.2. Borehole Geologs with sketch

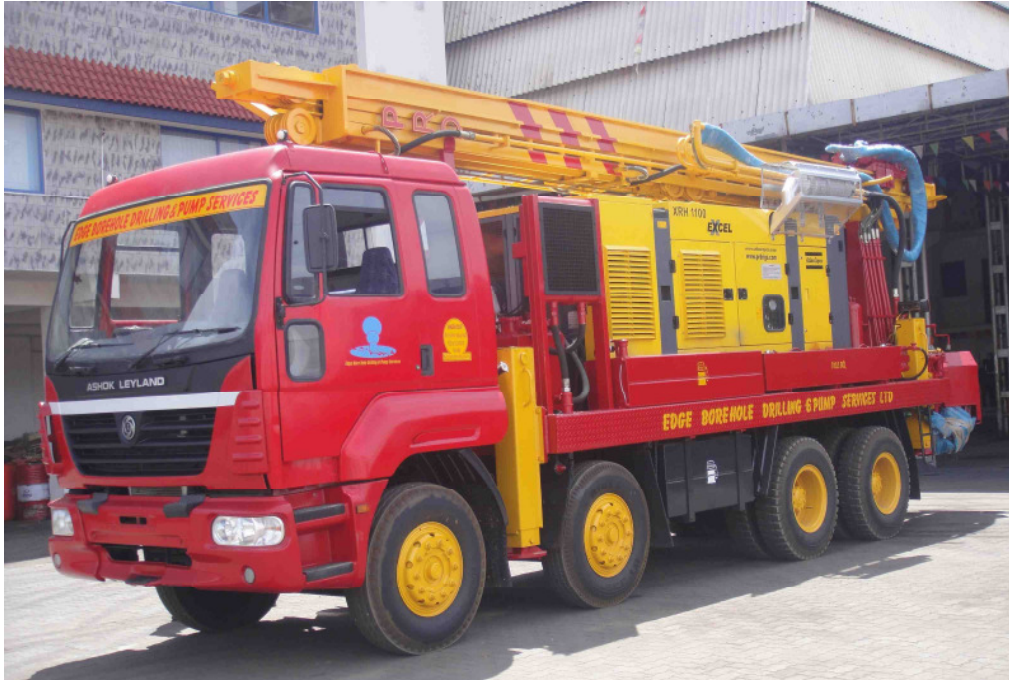
The drilling machine.

The work began as scheduled on the 9th of February and within two days the drilling had reached a depth of 200 metres. The drilling took place in different phases and water was struck at different levels. There are two sources of water: fractures and aquifers. The initial water found at a depth of 30 metres was an aquifer and is the water used in the local hand dug wells. This was cased in as it is not clean and fresh water. The second water hit at a depth of 85 meters was a fracture. They will both supply good water and are effectively underground streams fed by local aquifers.

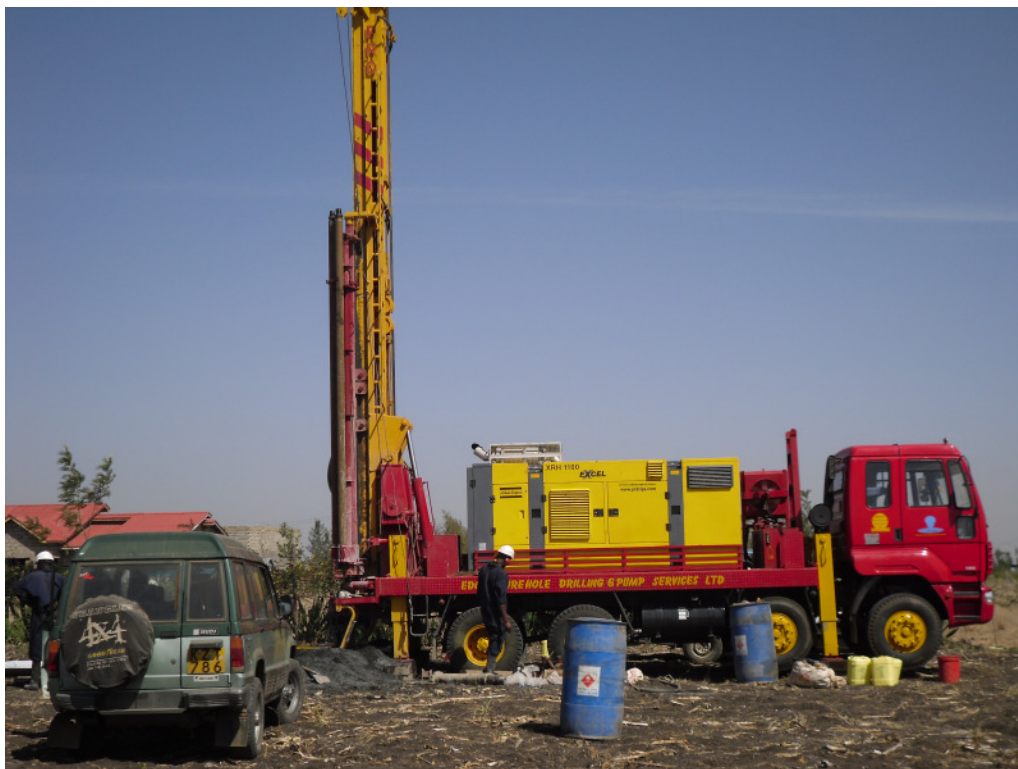
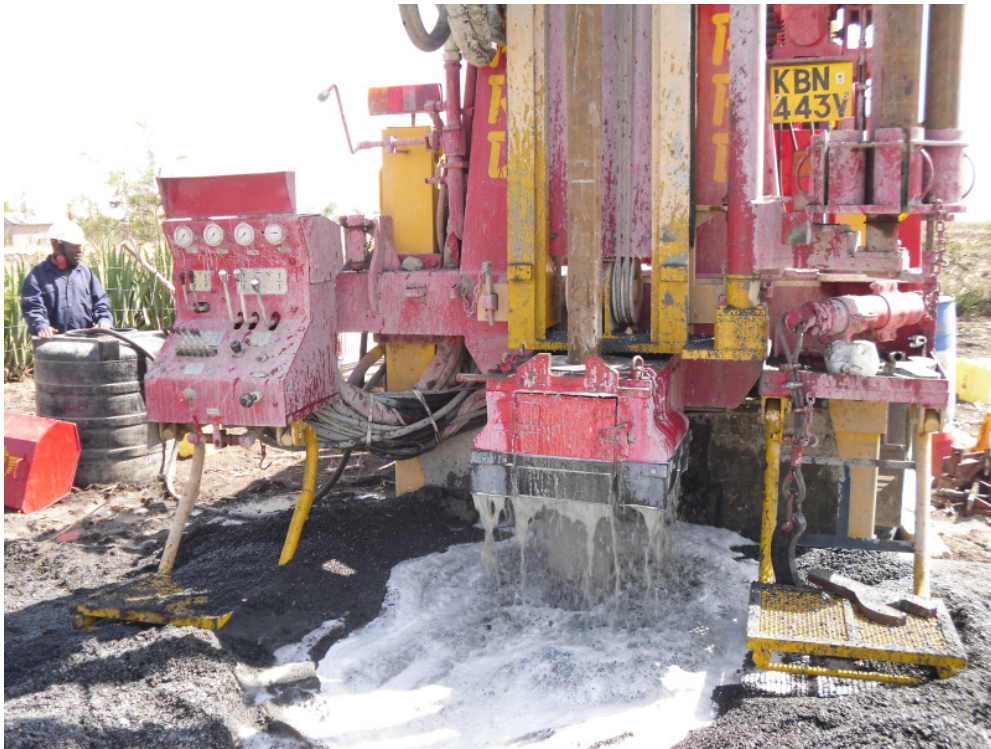
Water is found.

quantity of water that was being forced out suggested a high yielding borehole. It was impressive to see it shooting up to 7 metres high into the air.

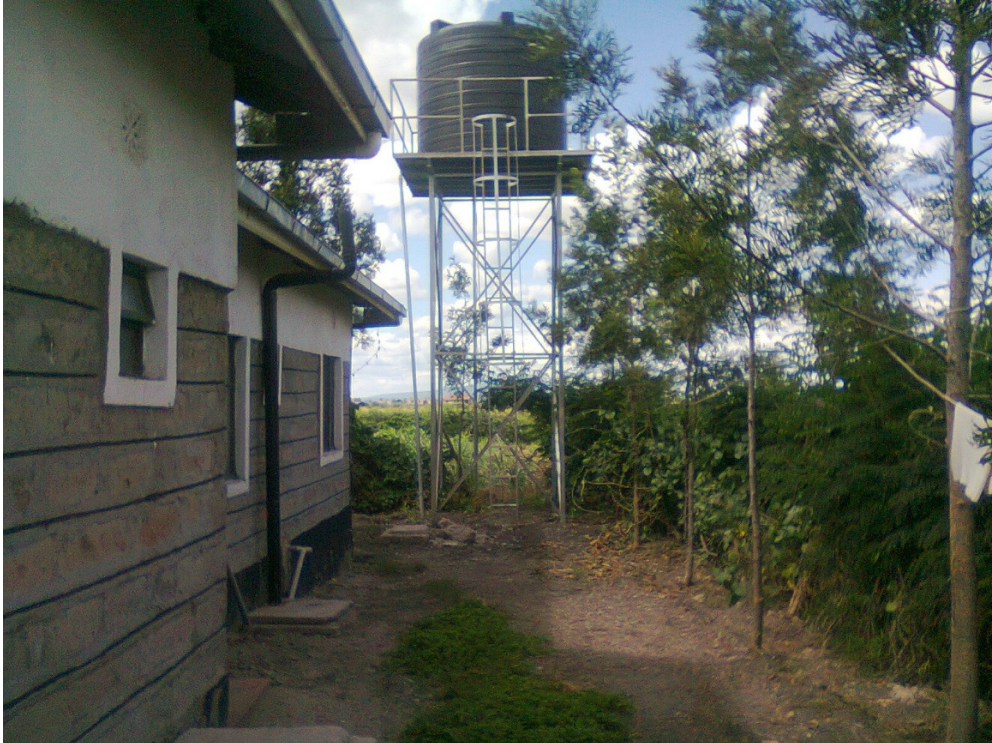
The tank and the tower which pumps water in the house.

The second phase which consisted of installing a tower, tank and completing the pipe work was successful. The installation of a 3 phase power which will enable a more powerful and reliable pump to be fitted was bought as this will help us to supply water to the entire village. The water tower and the control panel were installed. The children now have a sufficient supply of clean water for their daily use. We have also started to supply water to the village as word has rapidly got around that the maisha home has very clean water that does not taste salty.
